2.2.5 Hazardous Wastes and Materials

This section is based on the Hazardous Waste Initial Site Assessment (ISA) (August 2008) prepared by LSA Associates, Inc., an ISA prepared by GeoCon Geotechnical & Environmental Consultants (GeoCon) (May 2000), the Revised Preliminary Geotechnical Report prepared by the California Department of Transportation (Department) (August 2006), and the Ultimate Aerially Deposited Lead (ADL) Site Investigation Report prepared by Laguna Geosciences, Inc. (December 1, 2006). These documents are on file and available for review at the Department District 12 Environmental Engineering Branch.

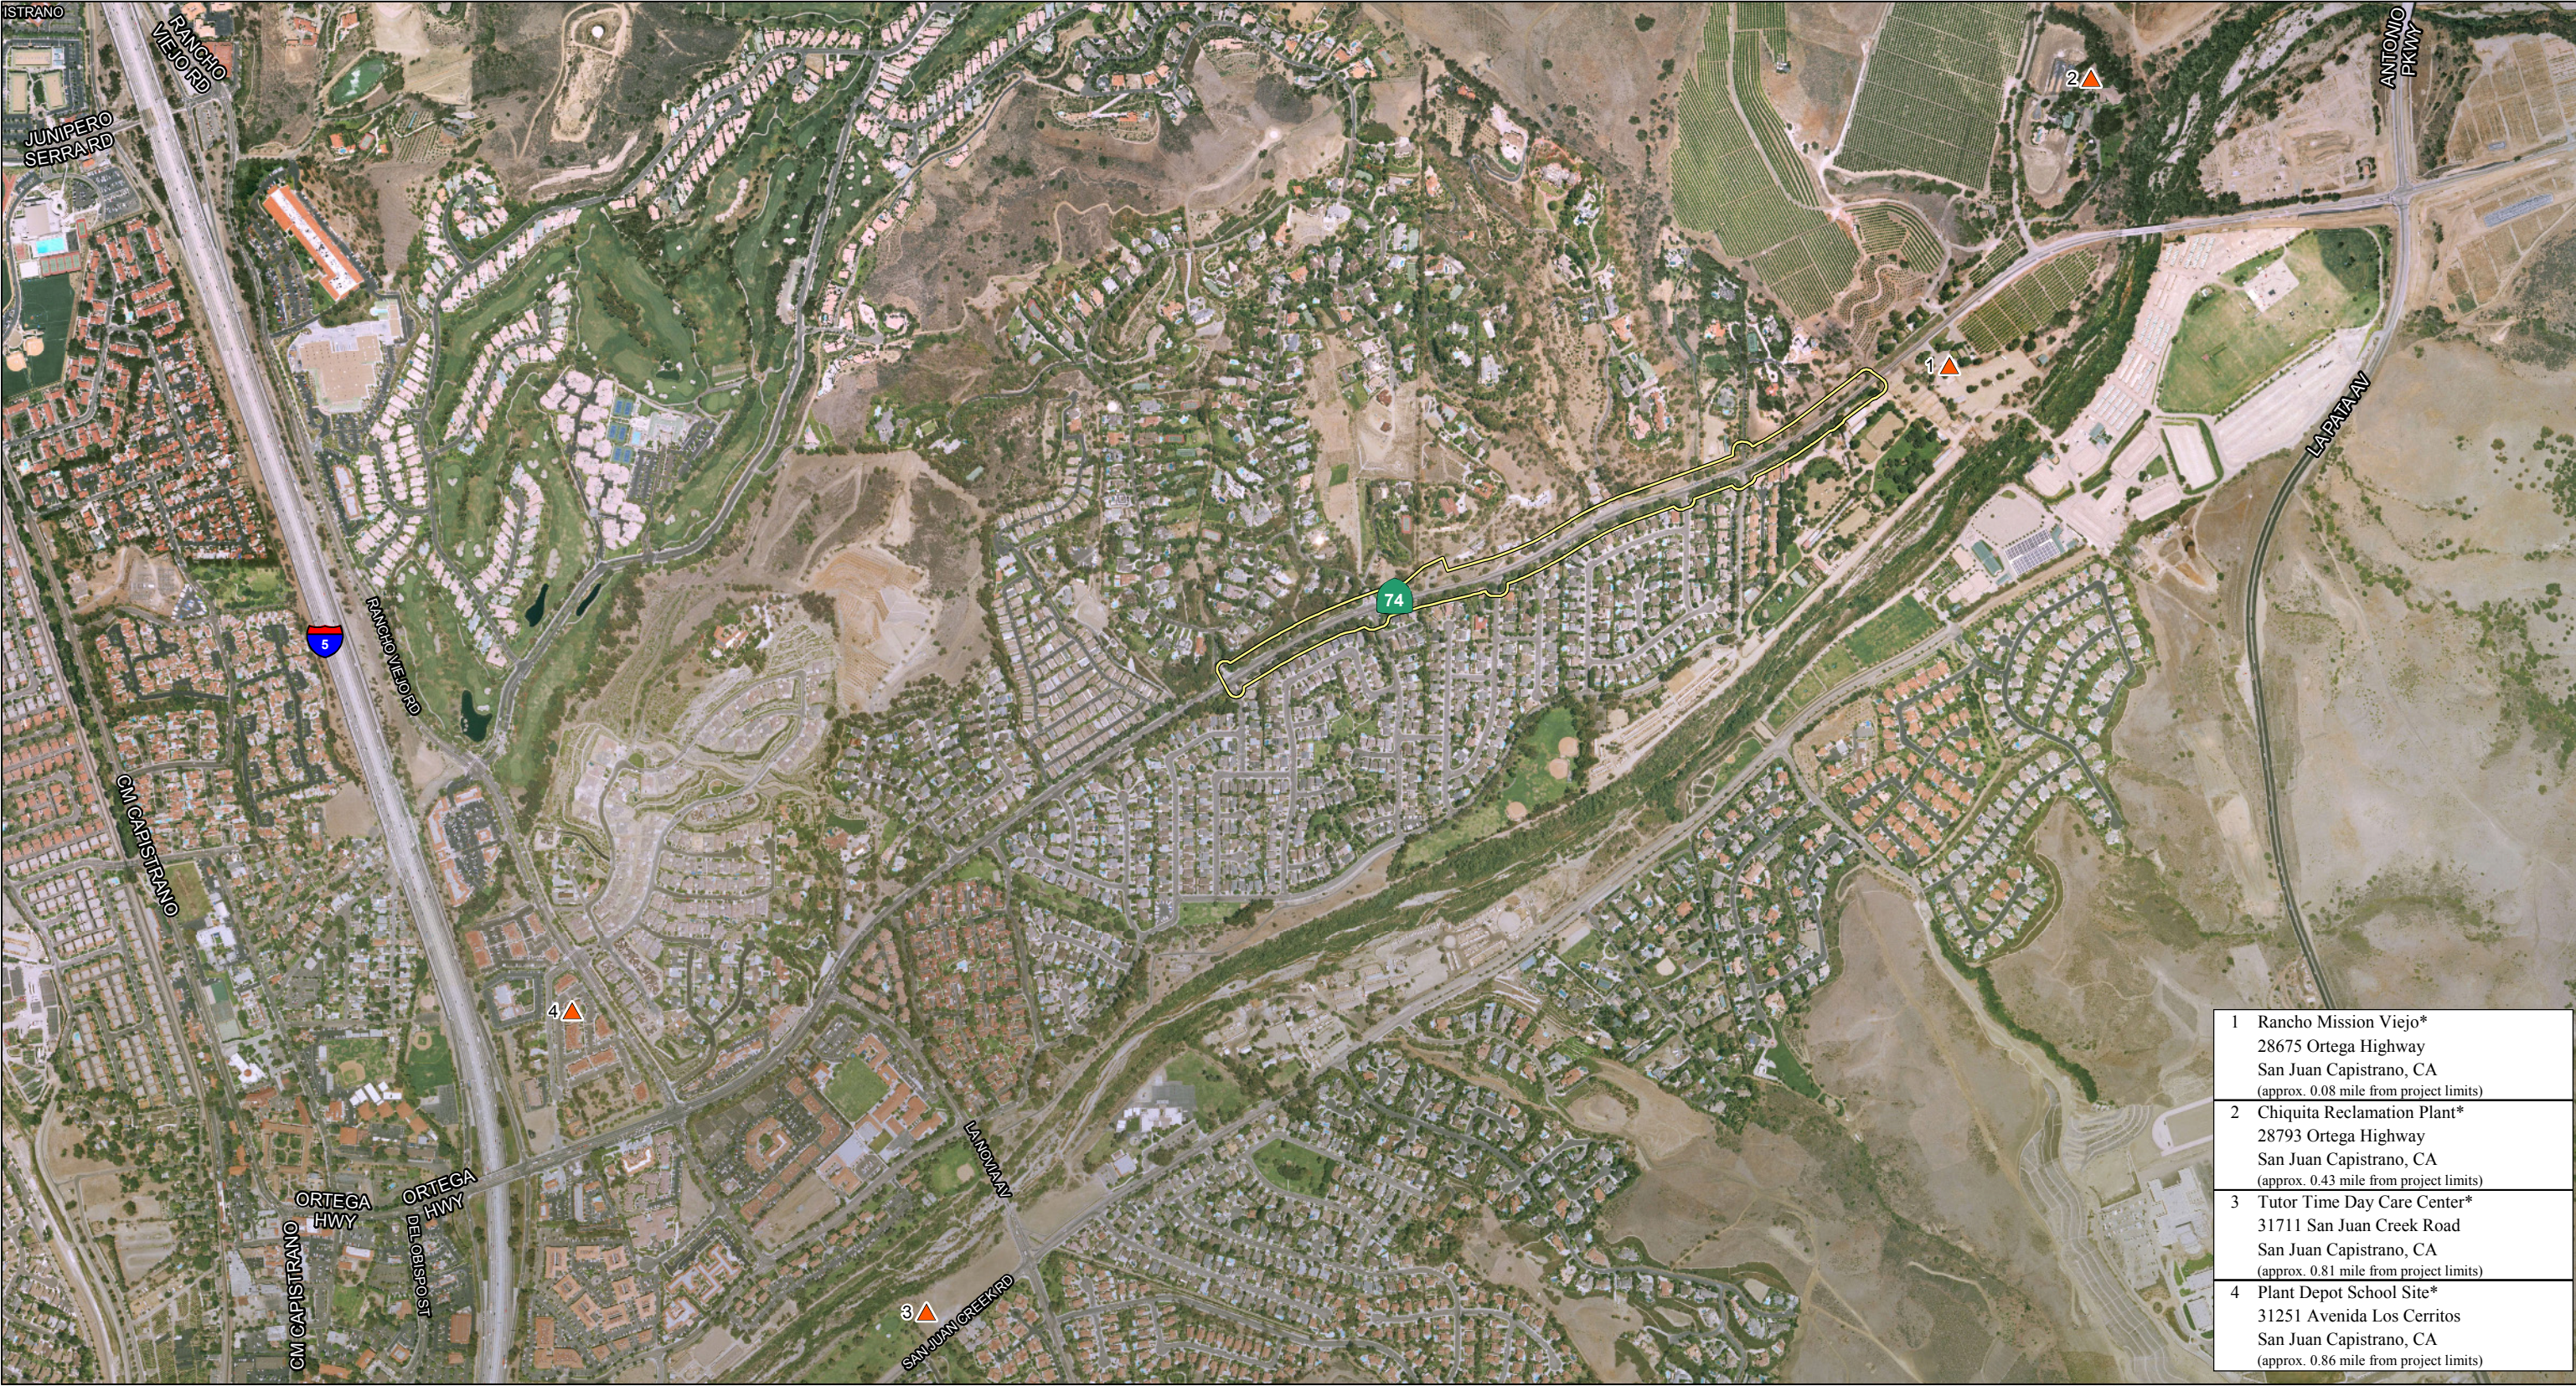
FIGURE 2.2.5-1

* THESE SITES ARE UNLIKELY TO IMPACT THE PROJECT

Hazardous Site Location Map

The search of federal, State, and local regulatory agency databases identified four known hazardous releases within 0.75 mi of the project site, including two leaking underground storage tanks (LUSTs) and two State sites (State) with reported hazardous releases. These sites are summarized in Table 2.2.5-1 and depicted in Figure 2.2.5-1.

Figure 2.2.5-1 ID No.	Address, Distance from Subject Site	Database	Status
1	Rancho Mission Viejo 28675 Ortega Highway San Juan Capistrano, CA (approximately 0.8 mi east of the project limits)	LUST	One LUST containing gasoline was discovered on March 18, 1992. The release impacted groundwater. A letter from County of Orange Health Care Agency (COHCA) was issued on May 9, 2002, indicating site closure.
1	Chiquita Water Reclamation Plant 28793 Ortega Highway San Juan Capistrano, CA (approximately 0.45 mi northeast of the project limits)	LUST UST	One LUST containing gasoline was discovered on February 24, 2000. The release impacted groundwater. The site was issued site closure on October 19, 2001.
3	Tutor Time Day Care Center 31711 San Juan Creek Road San Juan Capistrano, CA (0.47 mi from the project site)	State	According to the database search report, a Preliminary Assessment Report was conducted at Calmortgage and School Site Properties for future development as Tutor Time Day Care Center. On March 27, 2003, Department of Toxic Substances Control (DTSC) determined that "no action" was necessary regarding investigation or remediation of this facility.

4	Plant Depot School Site 31251 Avenida LOS Cerritos San Juan Capistrano, CA (0.74 mi from the project site)	State	According to the database search report, a Voluntary Cleanup Program was completed at the Plant Depot School Site on March 12, 2003. On January 13, 2005, DTSC determined that a "voluntary cleanup program" was necessary regarding investigation or remediation of this facility. According to the Envirostor database maintained by DTSC, the potential constituents of concern include arsenic and nitrates. No other information is available at this time.

The records search conducted for the ISA listed two LUST incidents and two State-listed facilities within 0.75 mi of the project site. One nongeocoded solid waste landfill (SWL) facility was also listed approximately 0.6 mi from the eastern perimeter of the project site. Nongeocoded sites consist of sites where missing or inaccurate information has been provided by the reporting agency, or where insufficient information prevents the proper placement of the site on a given map.

The second LUST site is located approximately 550 ft northeast of the project limits and is identified as the Chiquita Water Reclamation Plant. This facility has a documented release of gasoline into the groundwater. However, the LUST was closed and removed from the site, and the LUST facility was issued site closure on October 19, 2001. Therefore, the leak is unlikely to pose a concern during construction of the proposed project.
